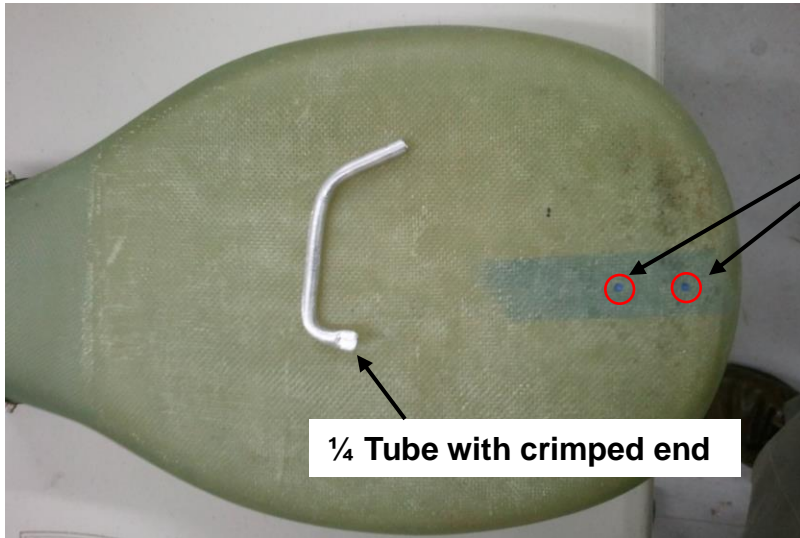
Original drain holes

1/4 Tube with crimped end

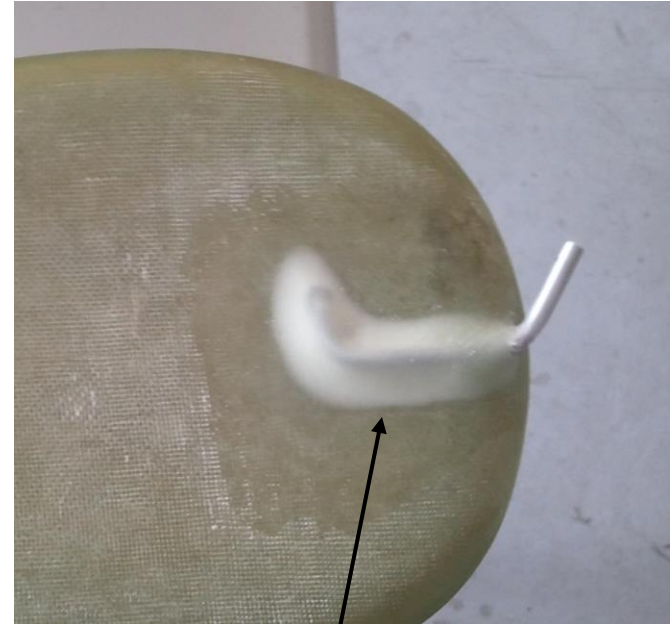
Drilled through existing drain holes into side of tube after tube was mounted and fibreglassed in.

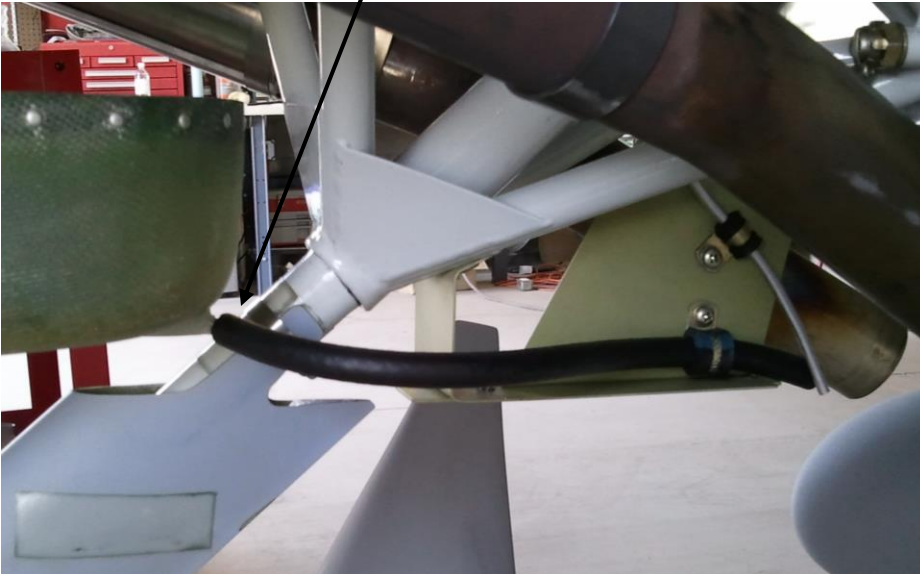
Hose clamp missing from photo
